**Watershed Assessment
of
Antelope Valley
And
Bear Valley Unnamed Tributary**

USDA Forest Service, Tahoe National Forest
and
Feather River Coordinated Resource Management, Plumas Corporation

February 2008

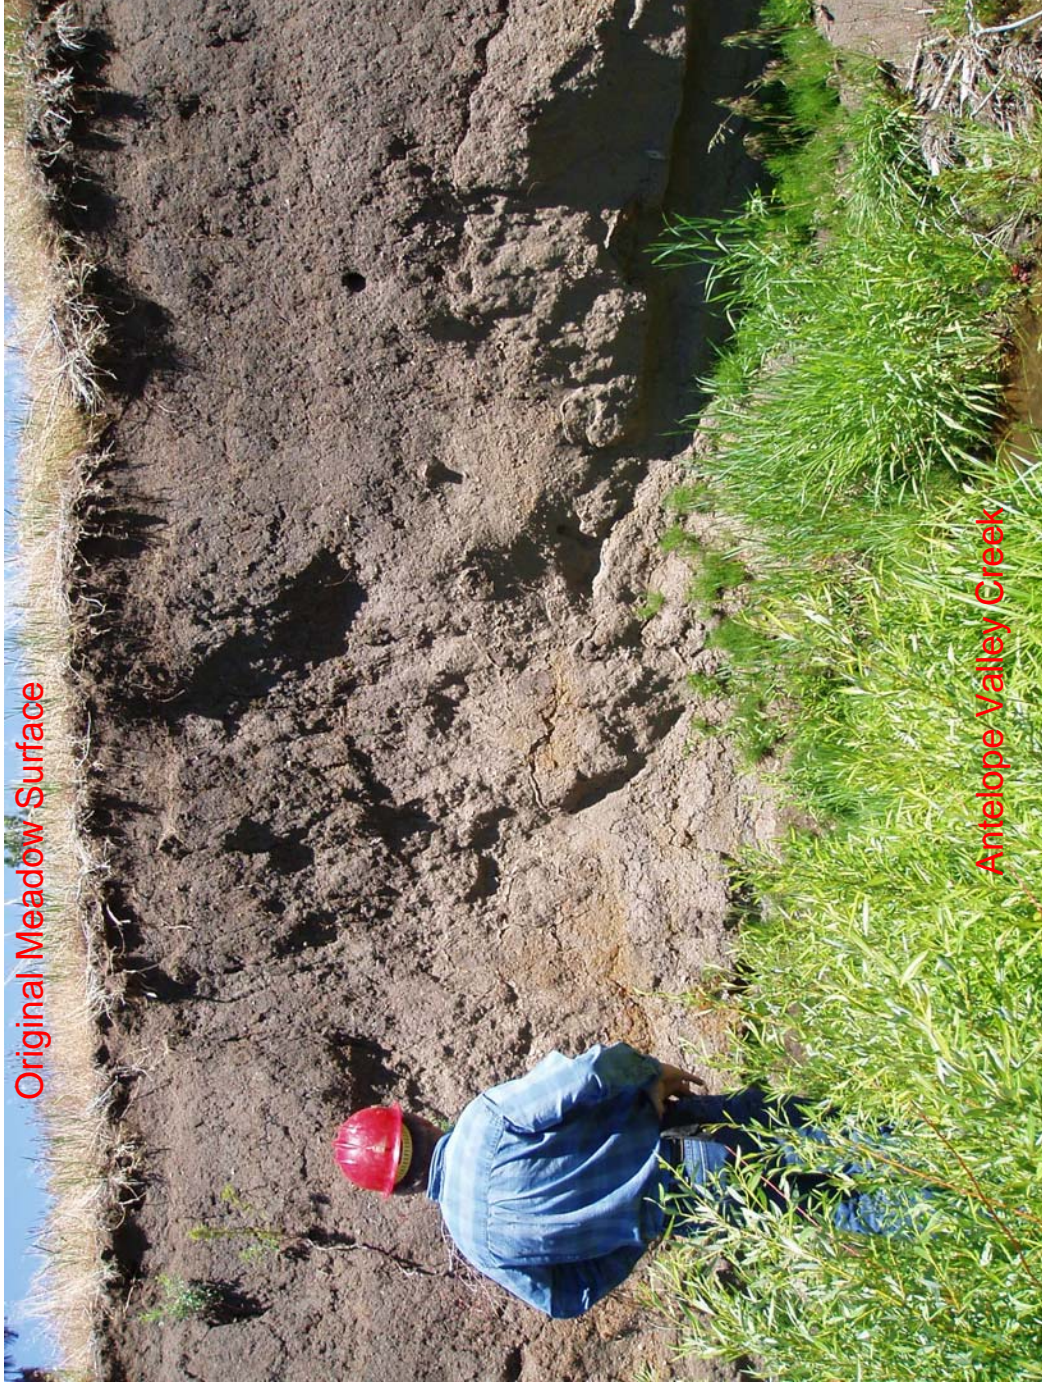
Photo 1

The stream channels of Antelope Valley are mostly degraded, incised into their original geomorphic features, due to historic and ongoing land use impacts. These impacts include over-grazing and trampling by livestock, logging during different land-use eras, road construction and maintenance, and water diversion and impoundments. Naturally occurring impacts, possibly exacerbated by human impacts, include wildfires, winter and spring floods, floods from summer thunderstorms, and mudflows. The most obvious and direct evidence of watershed change is degradation of stream channels and development of entrenchments (aka gullies) that contain most or all streamflows. Relocation and channelization of streams during the early logging era, construction and relocation of the Antelope Valley Road and construction of Palen Reservoir and the system of diversion ditches (Appendix A: Maps) are the primary cause and effect relationships. Stream channels are still actively down cutting within the entrenchments causing further widening (bank erosion) to take place. The result is continued loss of meadow lands and other landscape features (Appendix B: Photos 1 & 2) plus more rapid draining and loss of groundwater.

Vertical Bank of the Antelope Creek Entrenchment

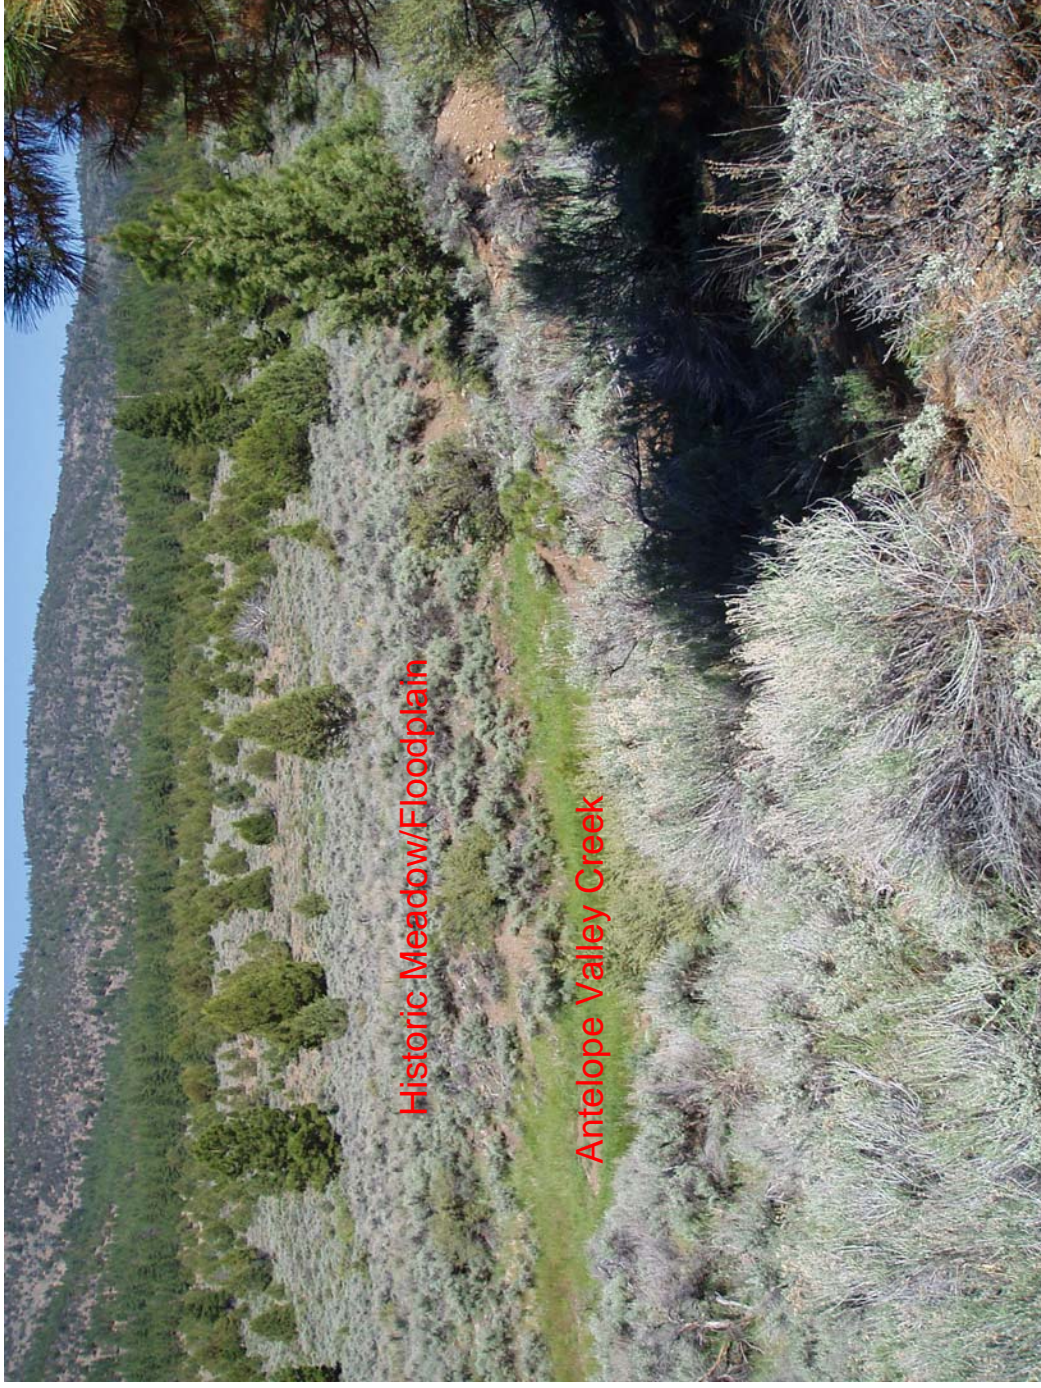
Photo 2

Antelope Valley Entrenchment

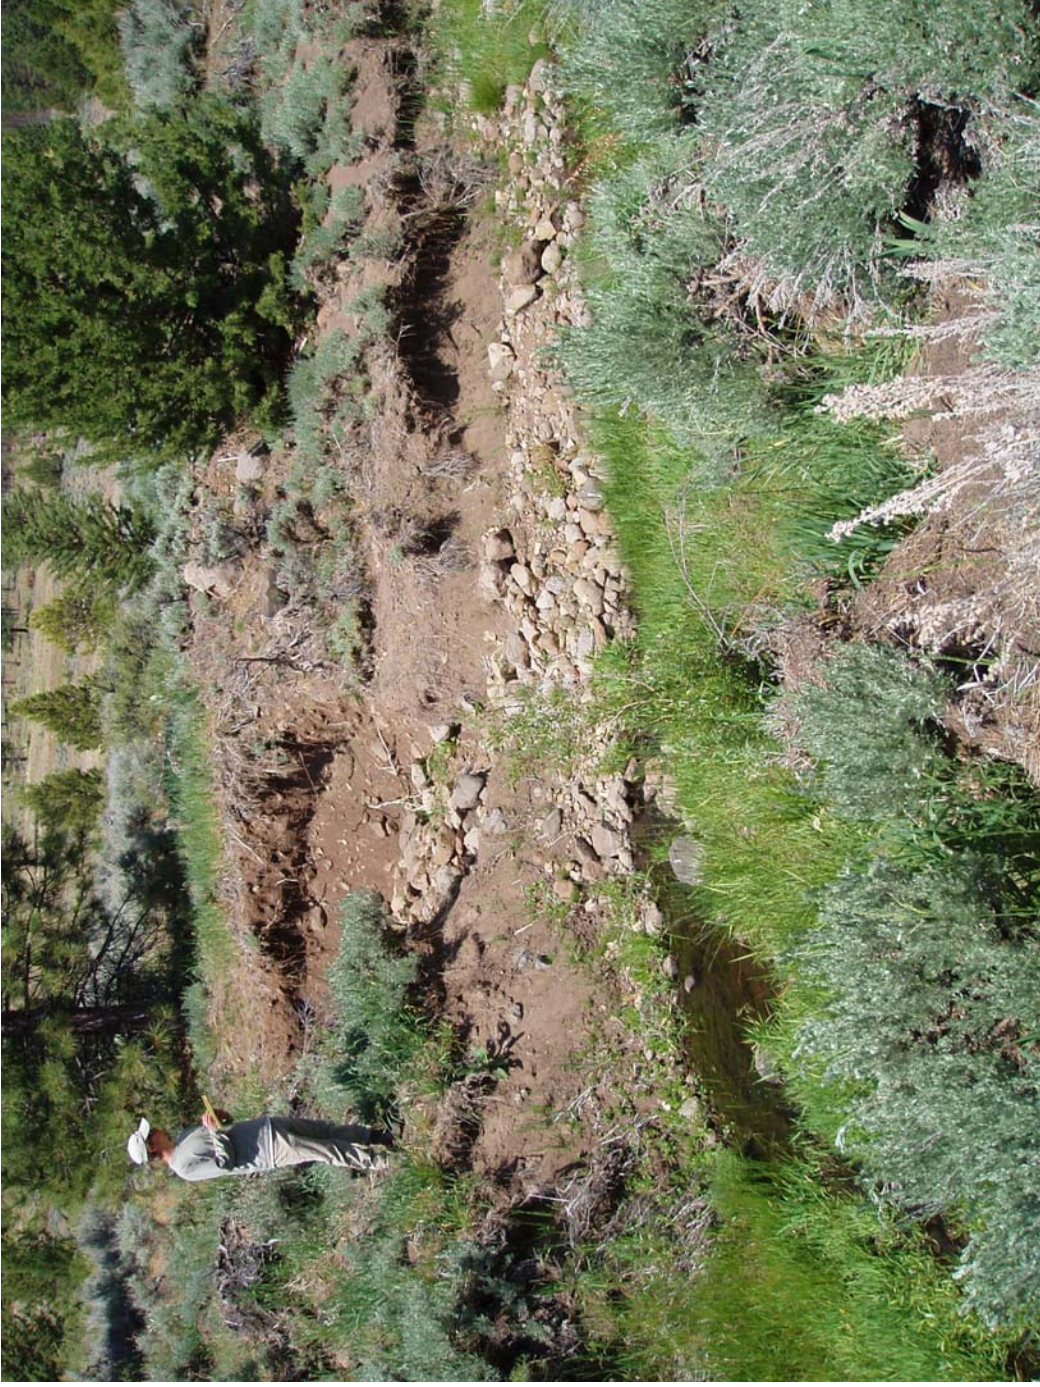
Photo 4

The most degraded feature is the main Antelope Valley Creek channel. It now resides at the bottom of a ten-foot deep trench that continues to deepen and widen (Appendix B: Photo 4). It has little to no access to its natural floodplain and it continually drains the watershed-long groundwater aquifer. The proposed actions are to obliterate the existing entrenchment and return streamflows to the historic system of remnant stream channels and meadow floodplains. A conceptual-level restoration plan has been developed to obliterate the main Antelope Creek entrenchment from the top of the valley downstream to Palen Reservoir (Appendix B: Maps; Appendix D: Antelope Valley Meadow Restoration Proposal and Cost Estimates). Natural floodplain functions would be restored, including 1) lower flood peaks and frequency (Appendix F: Flood Frequency Analysis), 2) greater groundwater retention and higher groundwater table, 3) vigorous plant growth and expansion of the riparian area, and 4) little to no erosion of the stream system and little to no delivery of sediment downstream.

The Eroding Bottom and Banks of Antelope Valley Creek

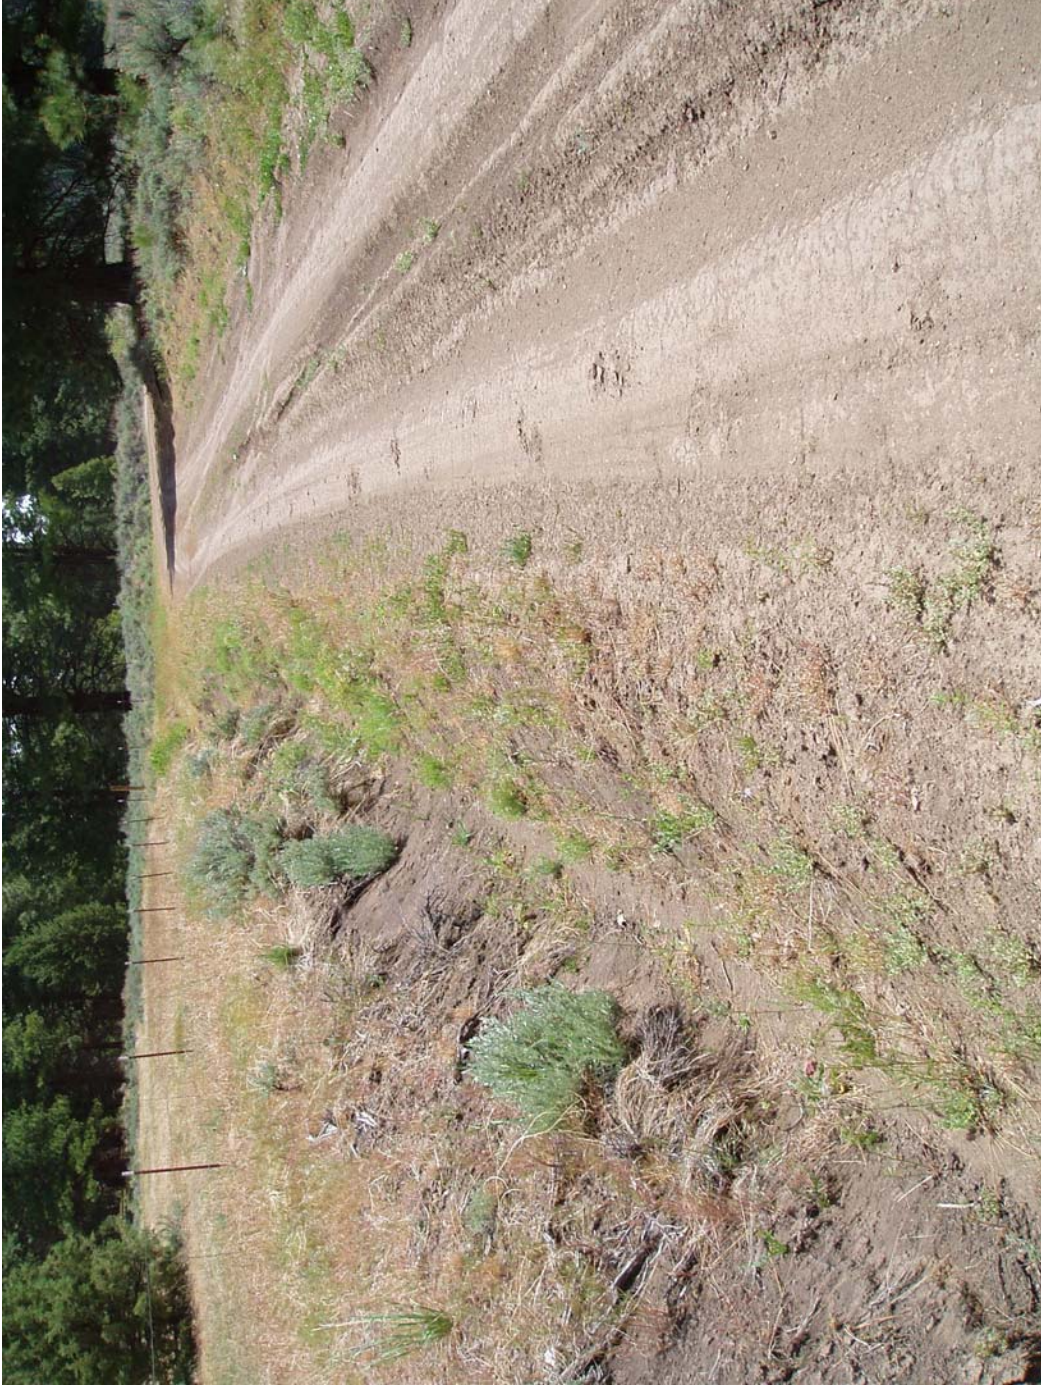
Photo 5

Tributary Stream Channel Caught in the Antelope Valley Road
Inside Ditch

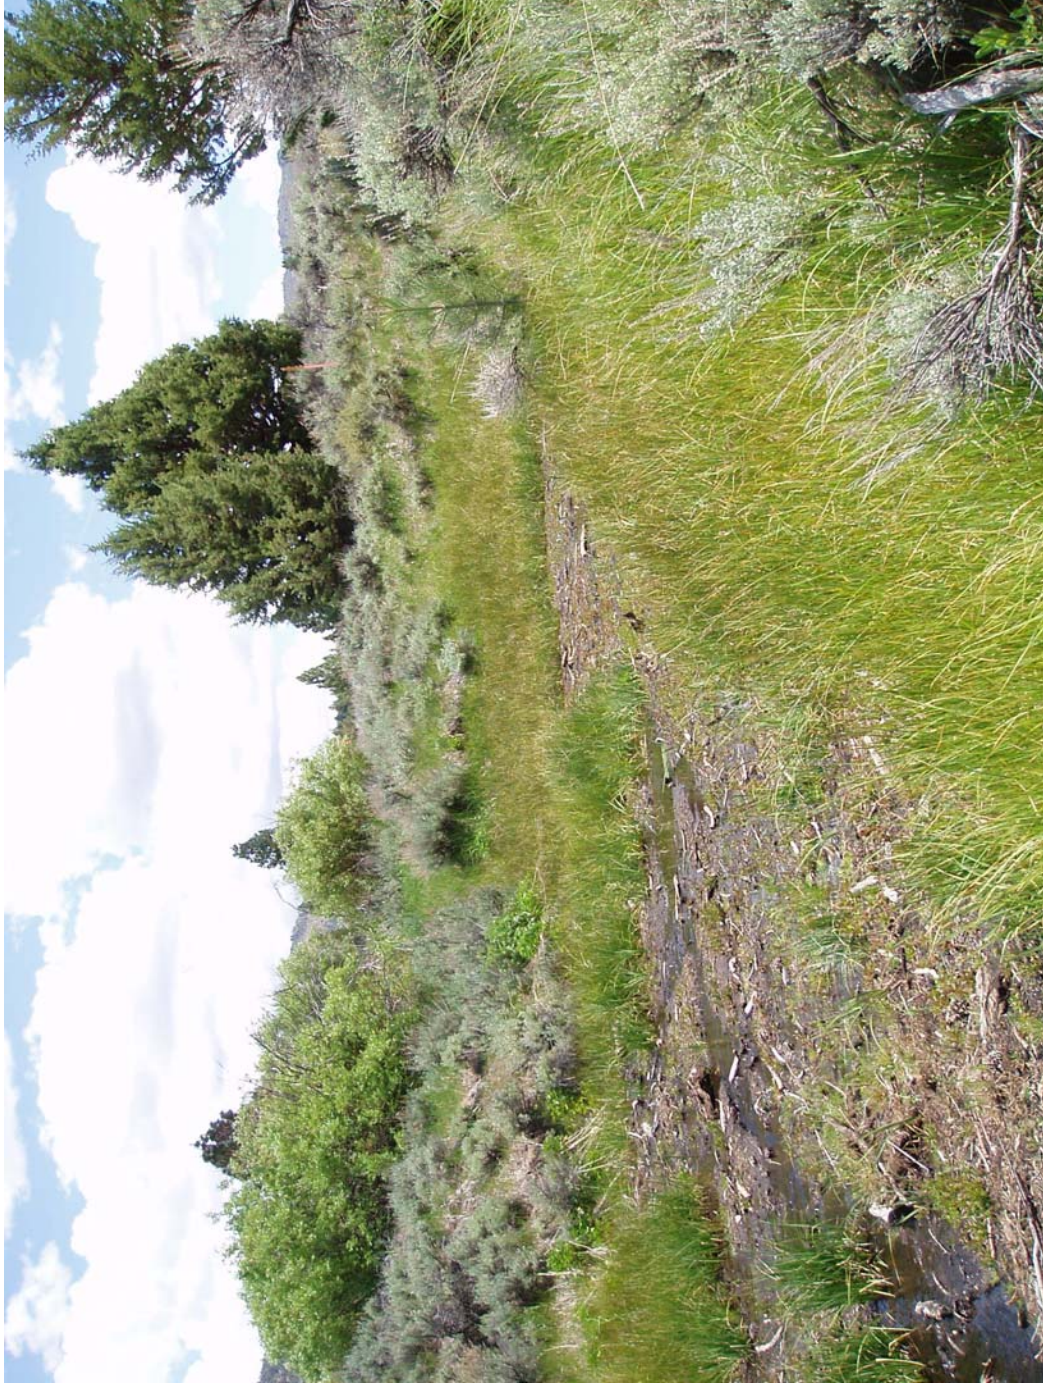
Photo 6

The Top of The Area Excavated to Supply Material For Palen Dam
Note Dewatering of the Meadow Above and the Sudden Drop in the Valley

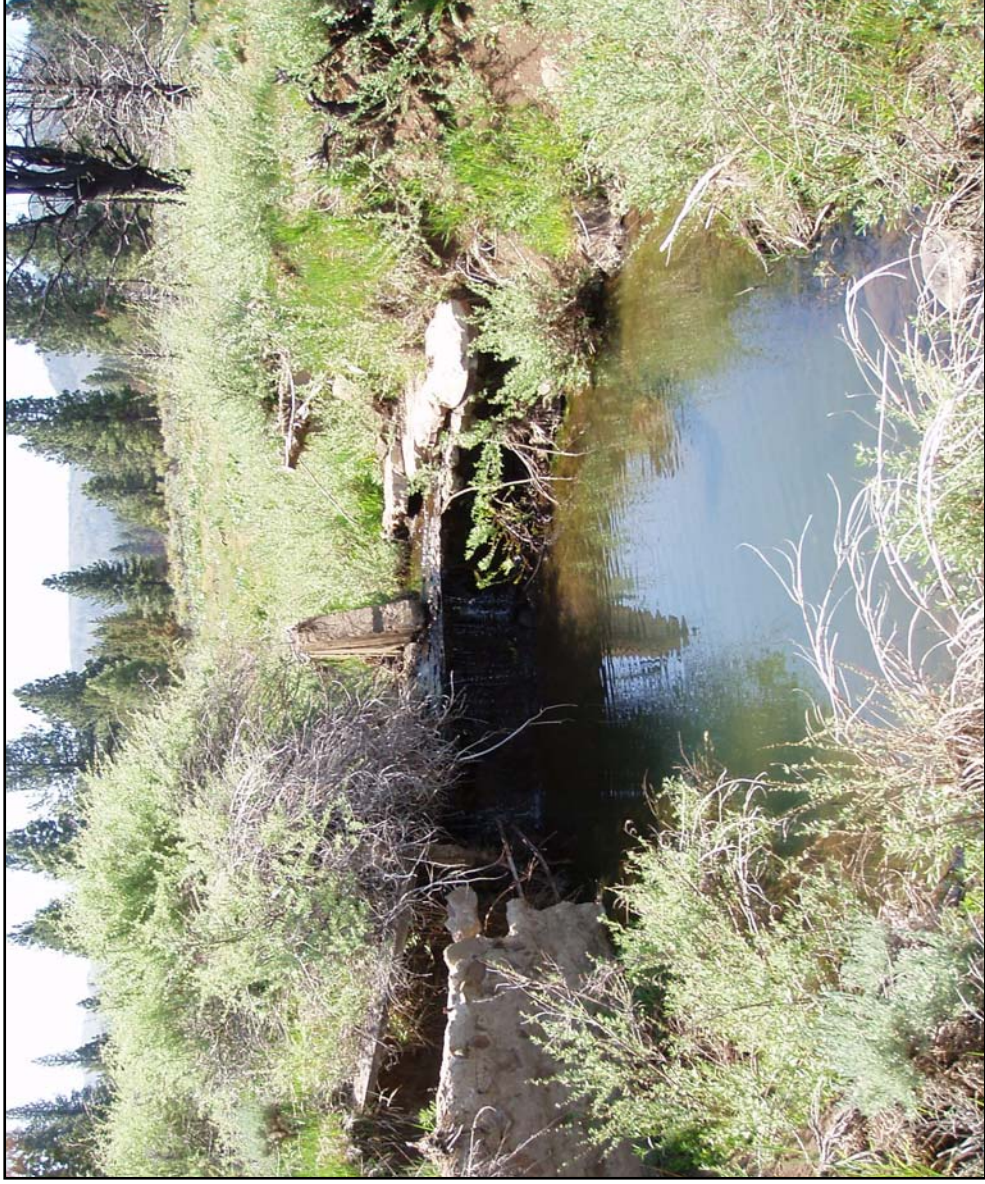
Photo 7

The water-works that diverts water around Palen Reservoir consists of a diversion structure (Appendix B: Photo 7) located approximately 2500 feet upstream of the reservoir and a ditch from the diversion works to the main Antelope Valley Creek ditch approximately 900 feet downstream of Palen Reservoir outlet. Palen Reservoir and dam is an obstruction to natural streamflows and the upstream diversion works and spillway structure has not functioned as designed for many years. Even though water is no longer diverted into the ditch, it intercepts a significant amount of water from the adjacent hill slope causing continued erosion of the ditch as it drains back to the main channel (Appendix B: Photos 8 & 9). The proposed restoration action would remove the small diversion structure and ditch and restore natural stream and hill slope processes.

Palen Reservoir Bypass Diversion Dam
Note Its Deteriorated State

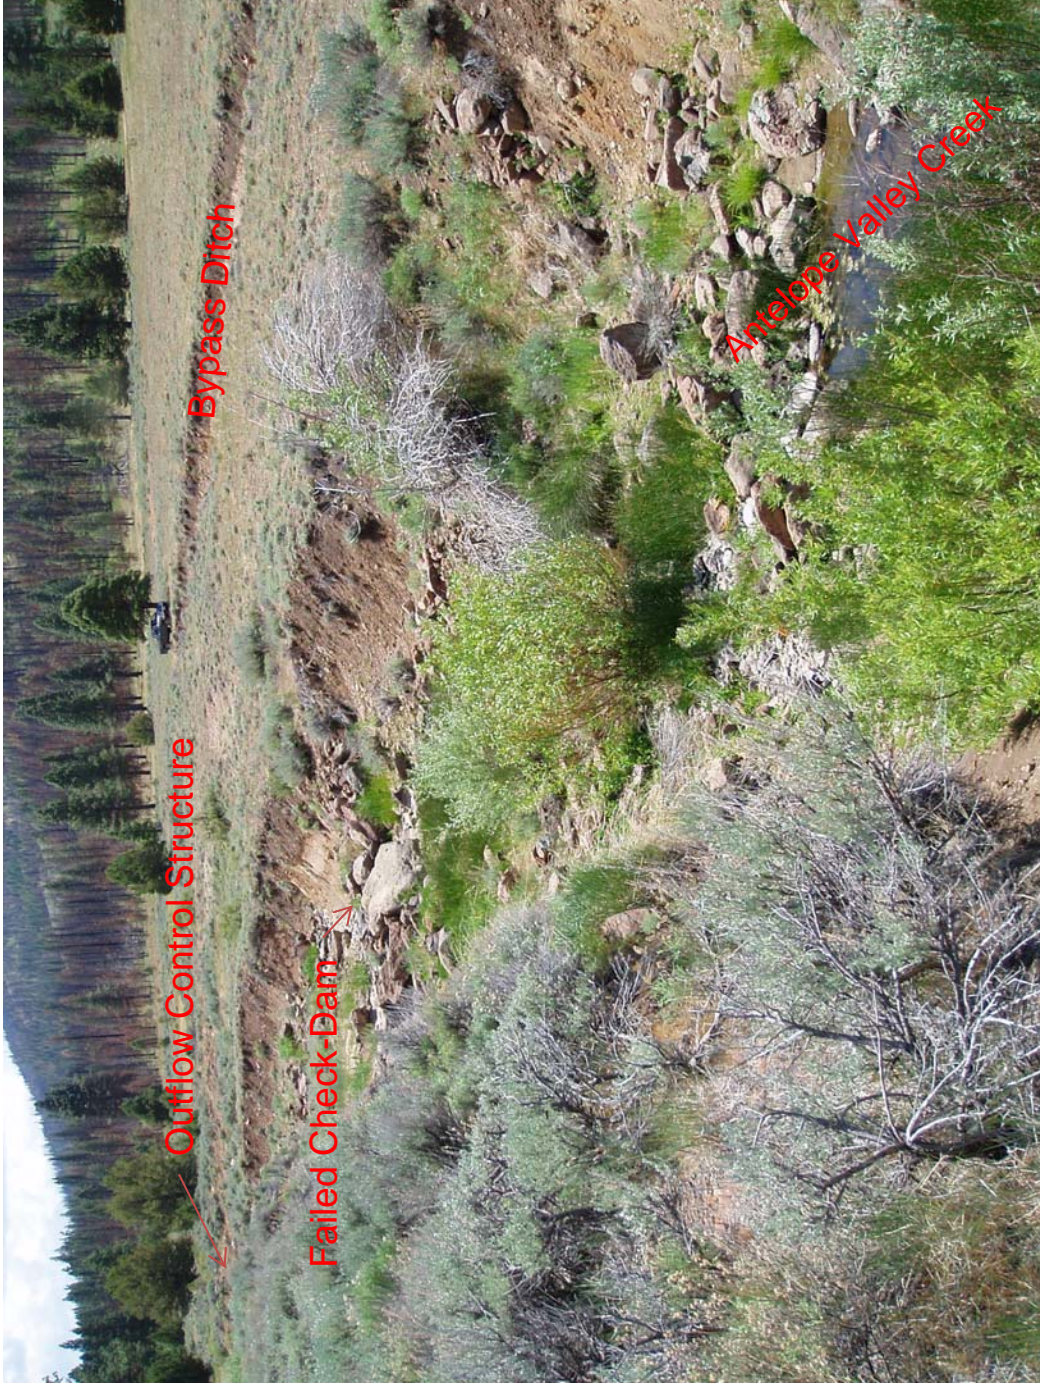
Photo 8

Failing Outlet Channel of Palen Reservoir

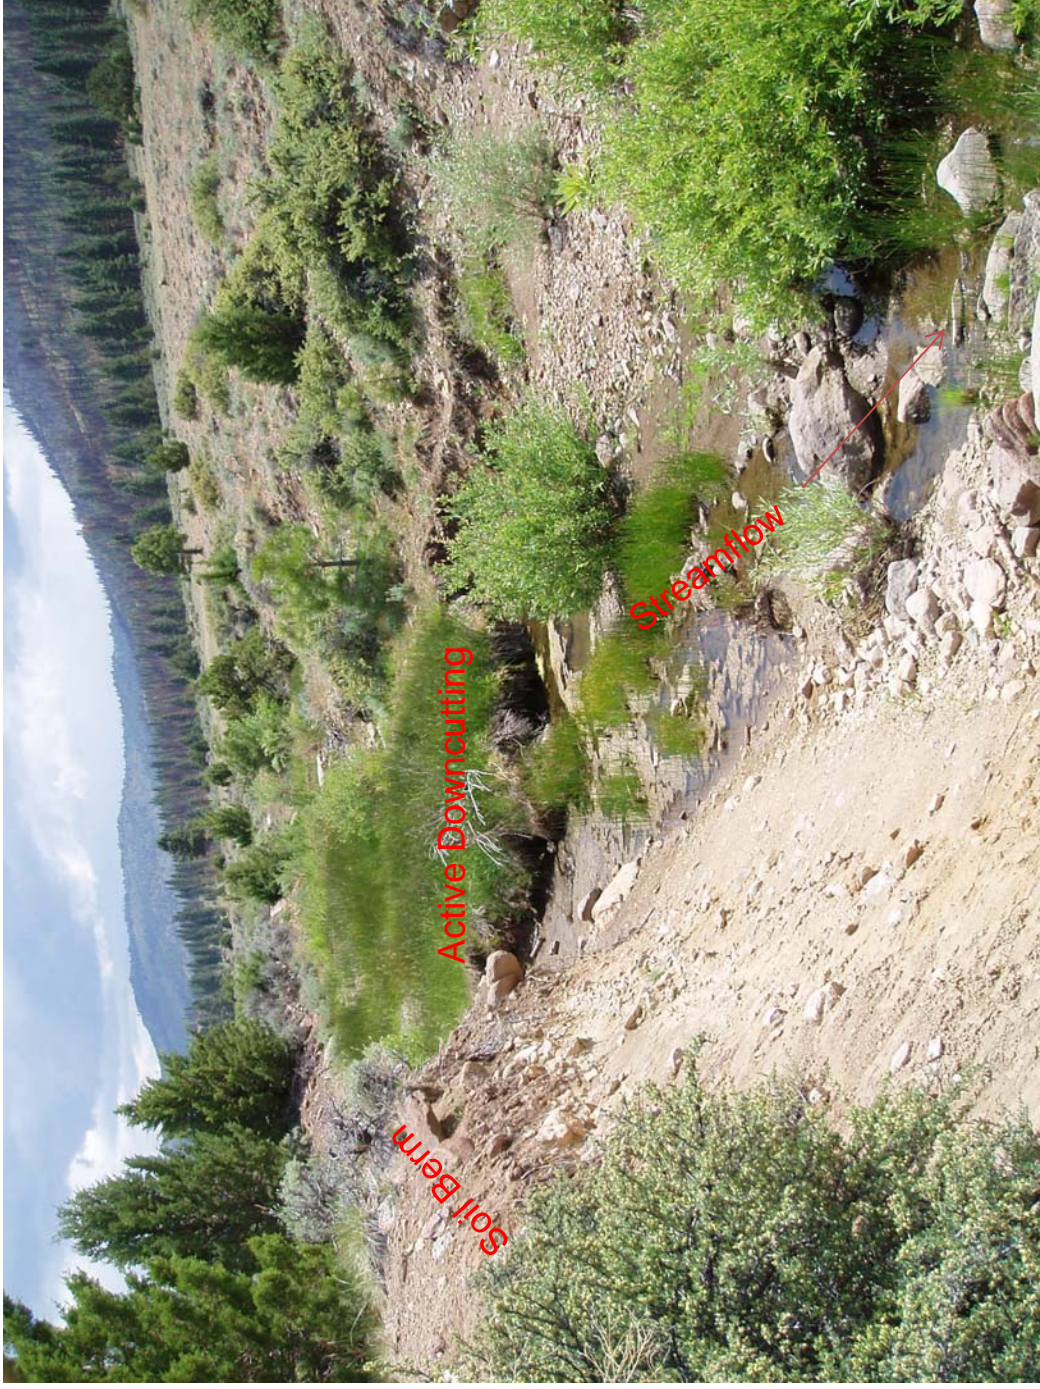
Photo 9

West-side Ditch and Antelope Valley Creek

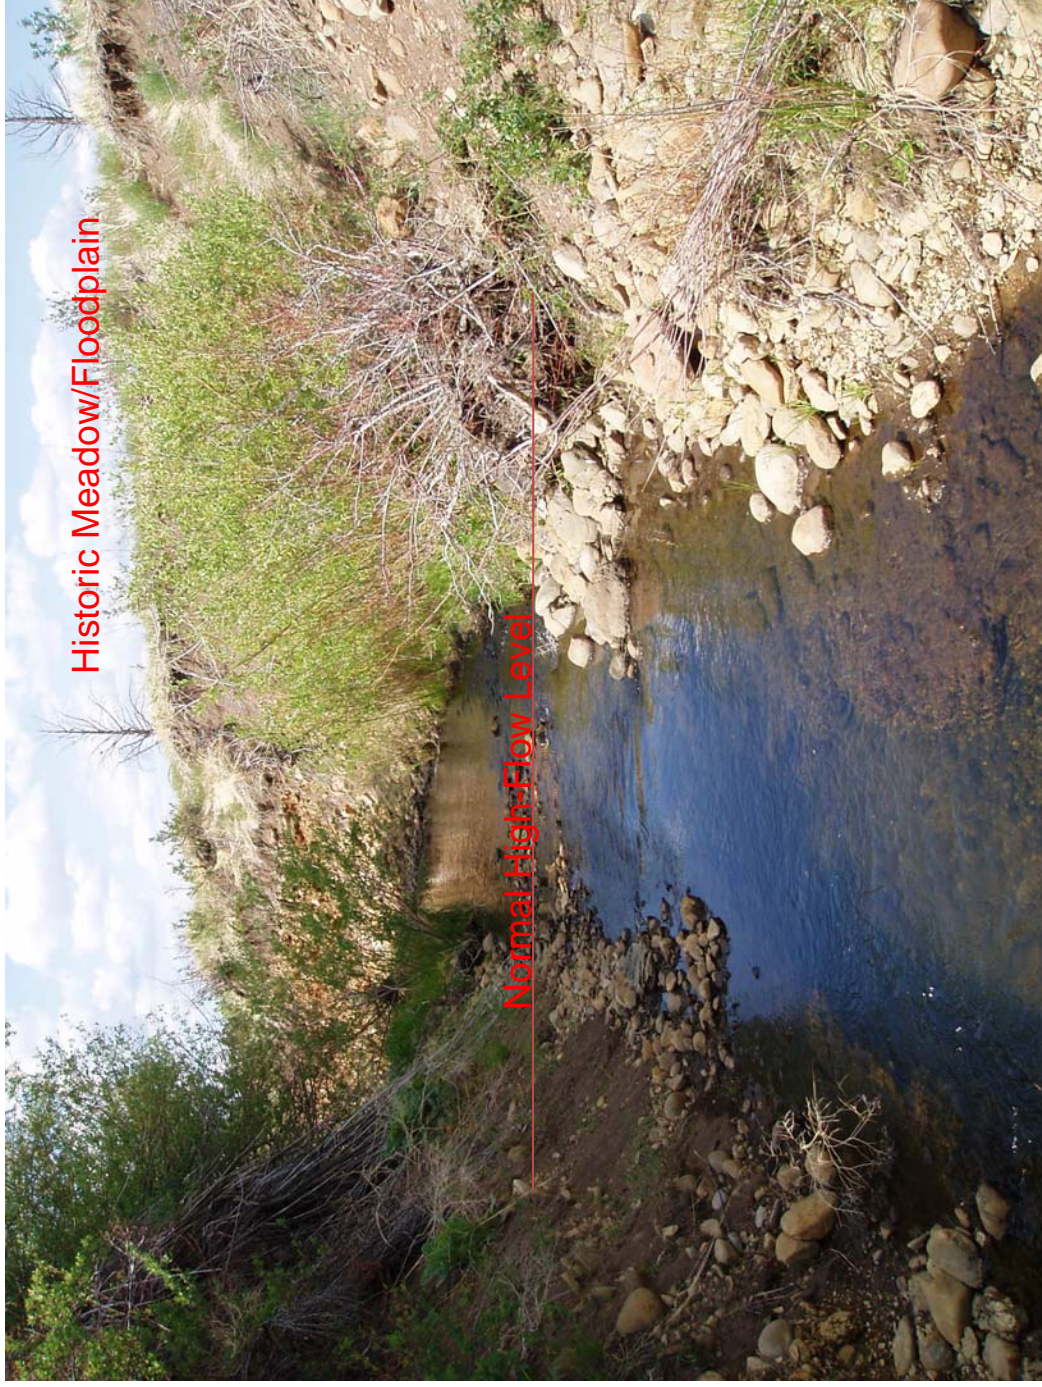
Photo 10

Bear Valley Creek at the Bottom of an Entrenchment
Note No Floodplain so Erosion Forces Against Banks is High

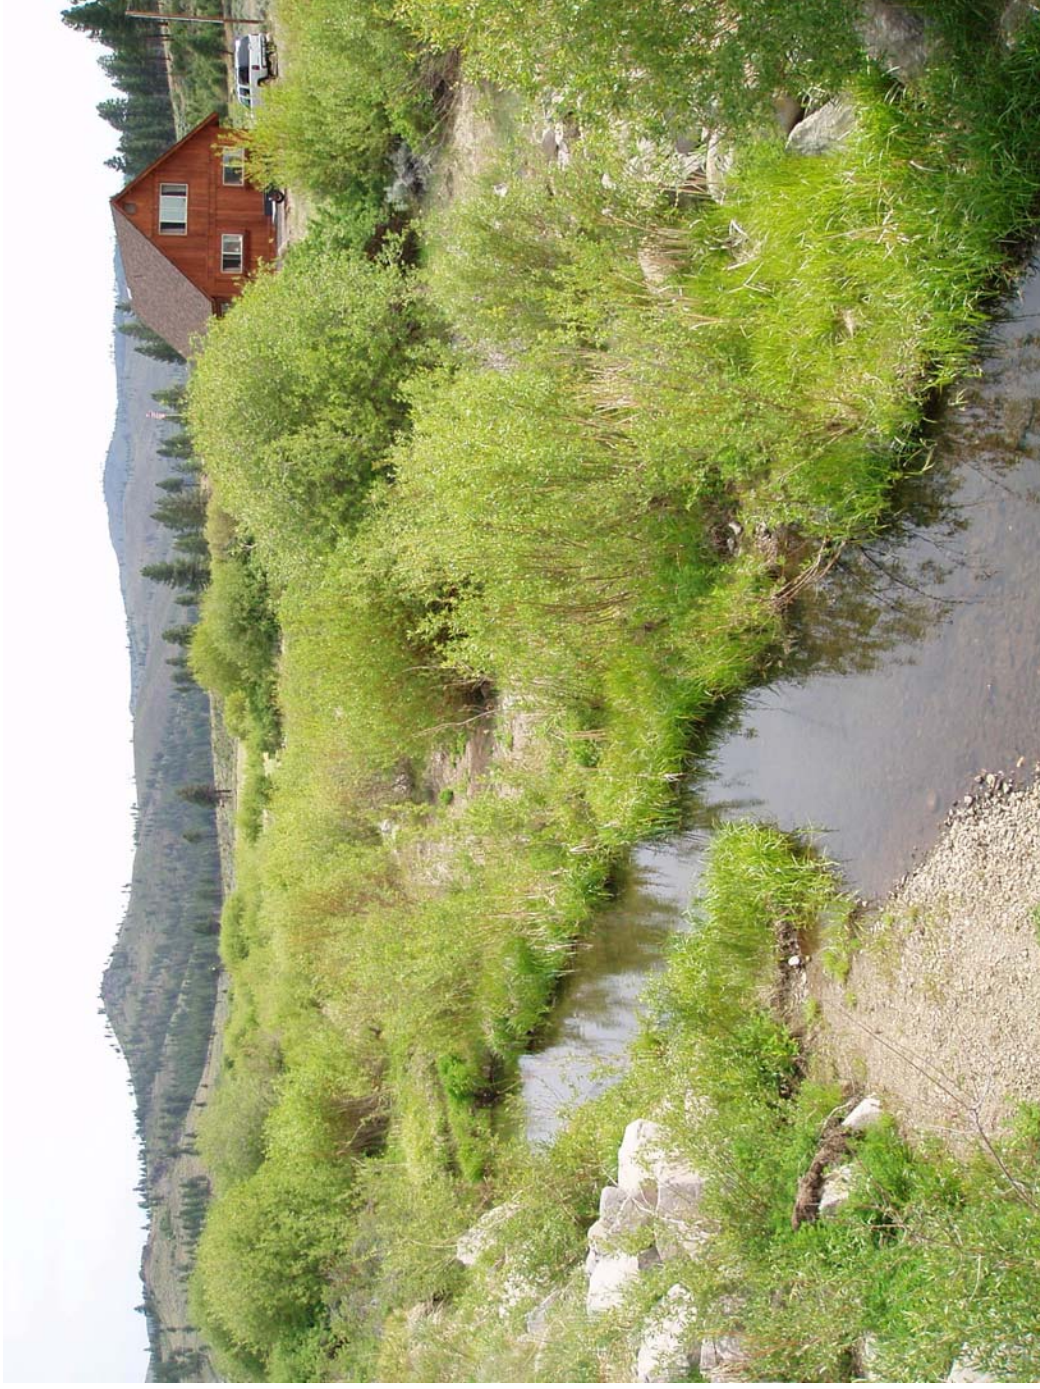
Photo 11

Bear Valley Creek Immediately Upstream of Sierra Brooks Drive

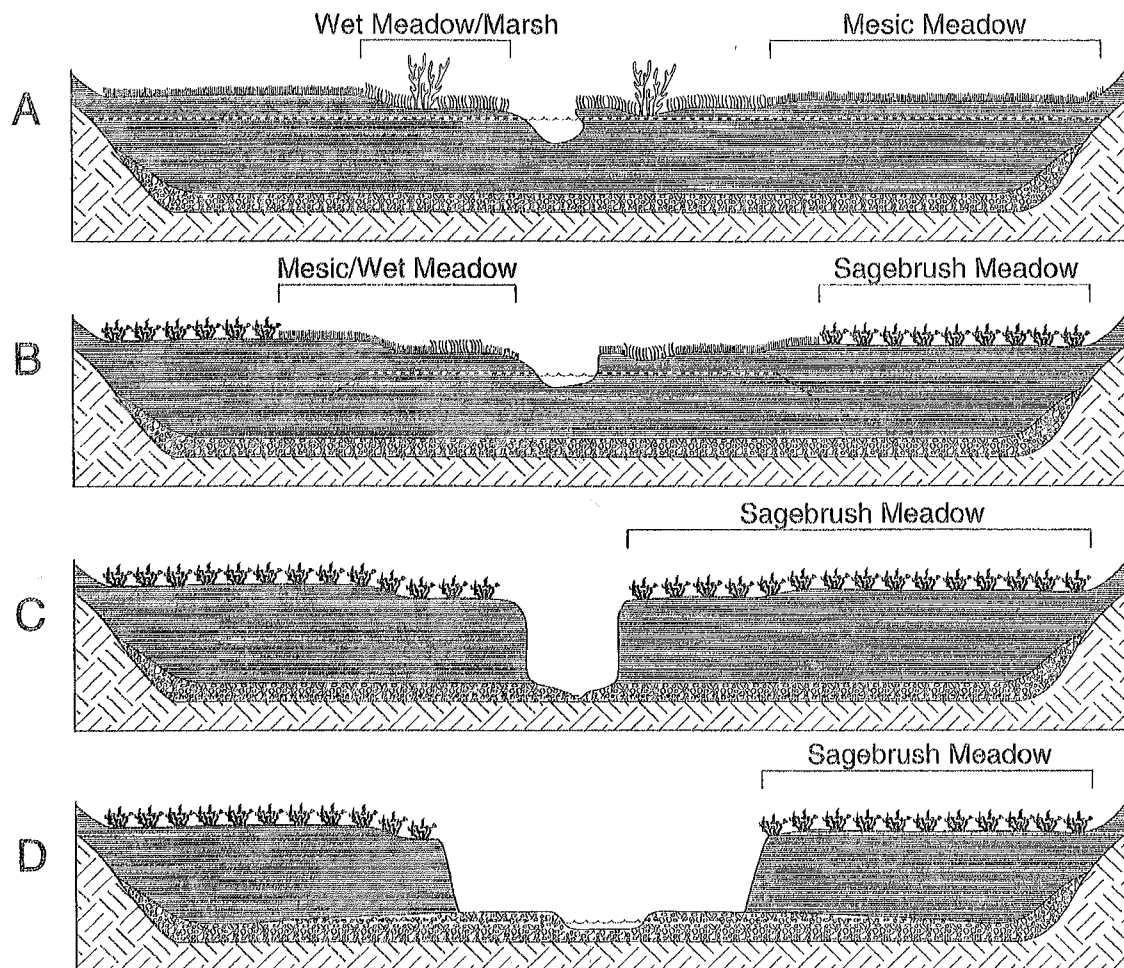
Diagram 1

The mill was constructed on the floodplain of Antelope Creek and an unnamed tributary, redirecting and channeling streamflows within the site. The main road, constructed to accommodate a steam tractor used to haul the rough-cut lumber was located down the middle of the main stream system, directly diverting and channeling Antelope Creek. The stream channel incised within its meadow floodplain as a result of these impacts and has resulted in the development of a system of entrenchments that contain stream channels at a lowered (inset) elevation (Appendix C: Diagram 1).

Succession of States of Degradation of the Antelope Valley Creek
And Entrenchment Development
